Rehabilitation of former Snowy Scheme sites in Kosciuszko National Park

By Elizabeth MacPhee and Gabriel Wilks

Ten years of restoration work at 200 sites within Kosciuszko National Park – sites damaged during the construction of Australia's most iconic hydroelectric scheme – is showing substantial progress and is contributing to the protection of the parks internationally significant ecosystems.

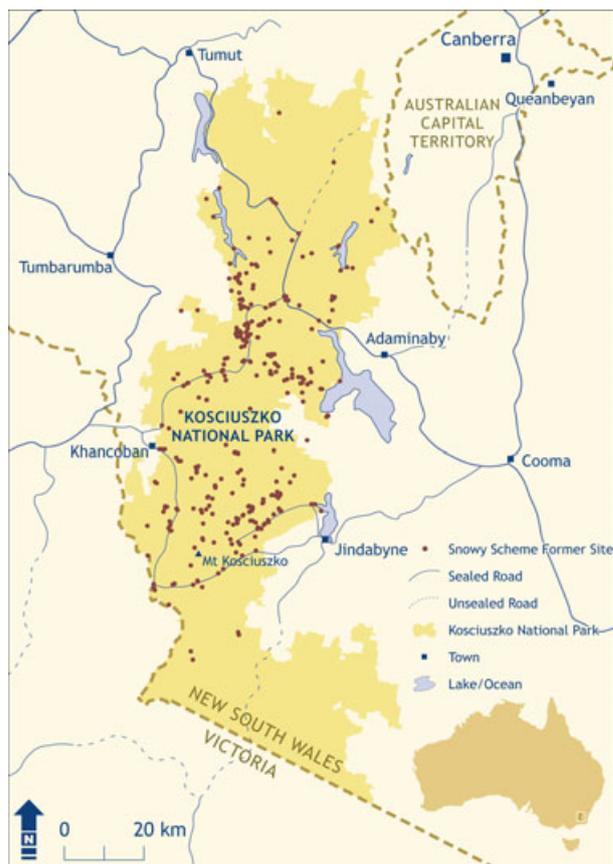
Figure 2. Distribution of the Former Snowy Scheme Sites within Kosciuszko National Park as surveyed by CH2M Hill. The survey informed the agreement between NPWS and SHL to fund and implement the Former Snowy Scheme Rehabilitation programme (Map courtesy NPWS Tumut).

valleys with spoil rock (Fig. 2), some of which has destabilised and washed downstream in major flood event, causing turbidity and sedimentation of water which has severely impacted aquatic life below the site (Harris *et al.* 2006). The erosion events have also filled natural ponds, blocked or diverted streams, and buried riparian vegetation, creating moist areas open to weed invasion such as willows (*Salix* spp.) and Scotch Broom (*Cytisus scoparia*). Further slips have the potential to cause greater damage in the future unless the sites are fully stabilised.

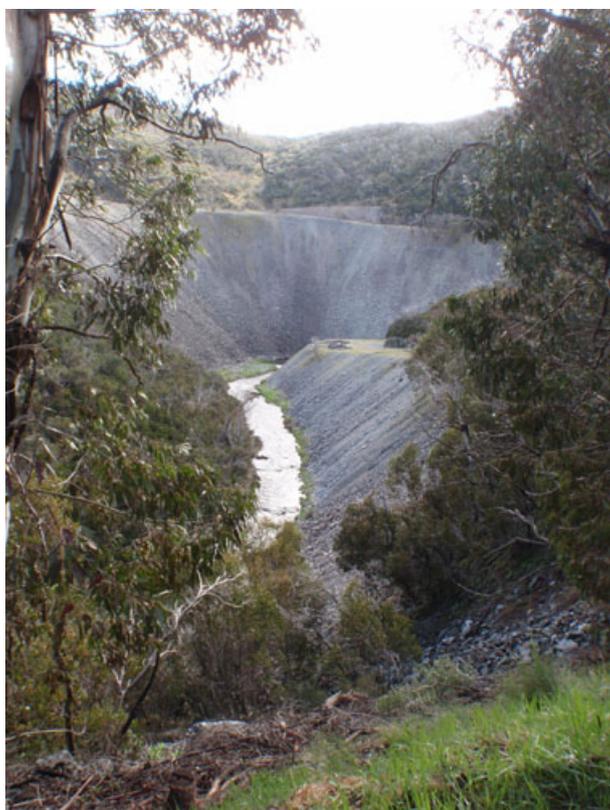
Figure 3. Happy Jacks Spoil Dump 1, in which over 970 000 m³ rock spoil was dumped both sides of the Tumut River, is another of the 35 major sites that has now been subject to rehabilitation earthworks and planting. Its condition prior to treatment, pictured here, illustrates the environmental risk associated with the filling of valleys with spoil rock, which can be further washed down by streams or even block or divert the streams themselves (Photograph Regina Roach).

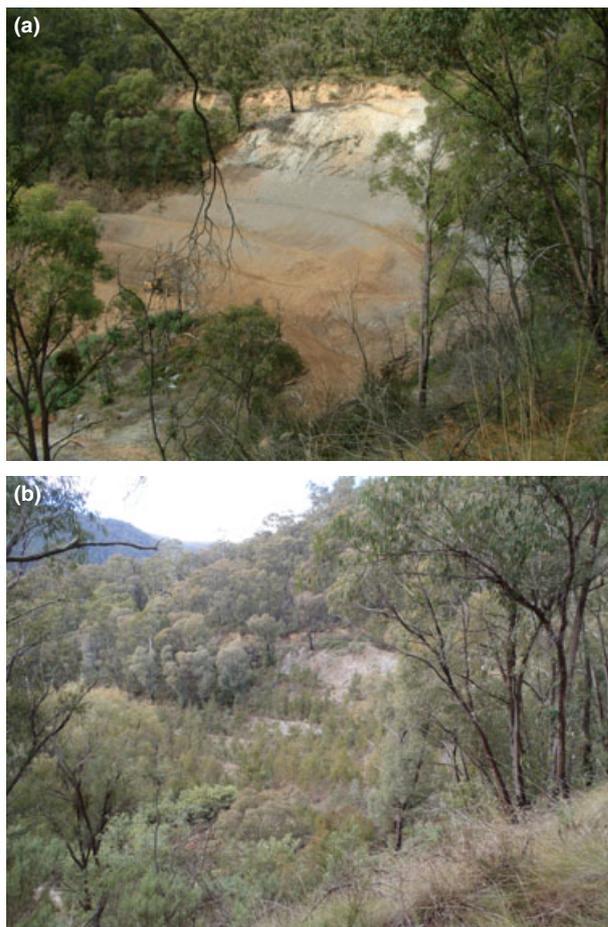
Figure 4. T2 Dogleg site was used to trial approaches to site remediation. In 2005–2006, the site was reshaped, metal removed and earthworks undertaken. A range of trial techniques including use of sediment mats, straw and compost were applied prior to planting 85 000 plants. (a) T2 dogleg just after earthworks and prior to soil preparation and planting and (b) same site 5 years after planting. The site is starting to integrate with the surrounding environment and is demonstrating ecosystem function with natural recruitment of species (Photographs NPWS Tumut).

Works commenced with reshaping of the site using standard bench/batter techniques (Fig. 4a). Machinery completing the earthworks was also used to bury relatively benign waste such as steel and to remove large treated Blackberry (*Rubus fruticosus*) bushes. Willows were cut down, poisoned and chipped, and the remnant

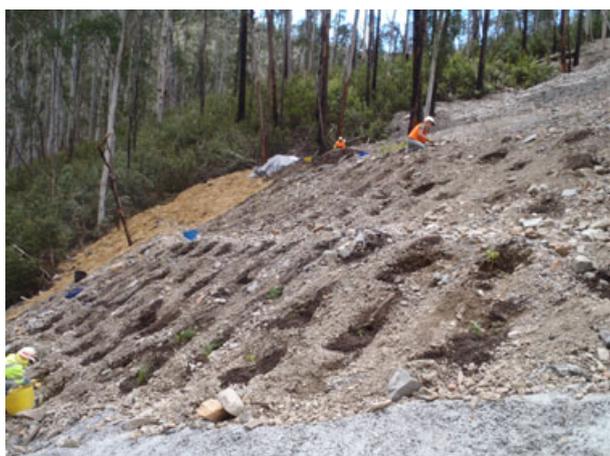
Figure 5. Planting into compost-filled holes at Bourkes Gorge #2 site. Site preparation involving surface shaping and creating permeable and fertile microniches is a key to successful plant establishment. Engaging local contractors is also important. Over 200 000 work days for local contractors has been generated by the project, which has created substantial benefits to local communities (Photo NPWS Tumut).

After lengthy planning and consultation with all stakeholders, the site was revegetated using a range of different techniques including a range of planting densities and hole sizes for a diverse plant species, along with the use of slow-release fertilisers, prewet water crystals and straw mulch (Appendix S1). Over 85 000 tubestock were planted. Direct seeding of native plants was also trialled, along with seeding with a sterile Rye Corn cover crop. ‘Log ladders’ were installed to create terraces (to slow water and accumulate soil and any dispersing seed, Tongway & Ludwig 2006) and to assist with access for the planters working on very steep slopes (Fig. 5).

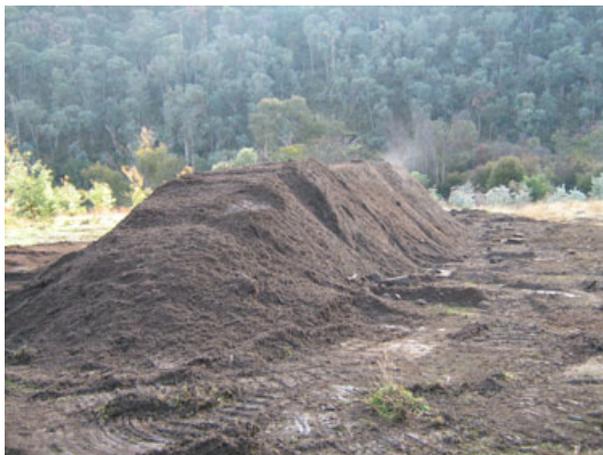
Figure 6. Compost used in the revegetation works is prepared for the project, based on aged waste fortuitously remaining from decommissioned regional sawmills.

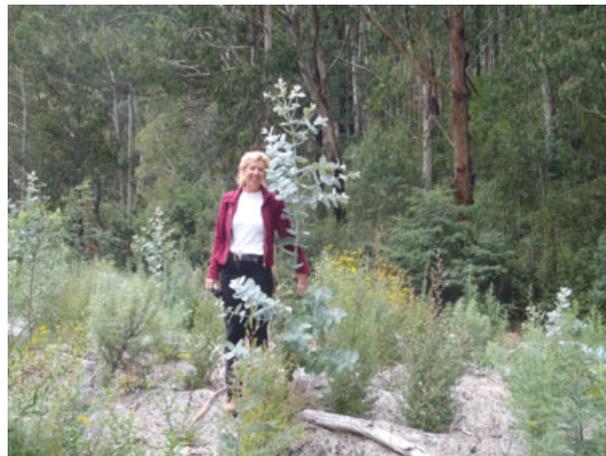
Figure 7. Rehabilitation Officer Liz McPhee is pictured at Bourke's Spoil Dump #2, where monitoring has shown outstanding survival and growth rates within 1 year, with 19 native species establishing, all sourced from the surrounding vegetation. Other native species are now colonising (Photograph NPWS Tumut).

2 Bourkes Gorge Spoil Dump # 2: This spoil dump containing some 300 000 m³ of rock was reshaped for stability, accessibility and safe water movement across the site in 2009–2010. Slope angles were reduced from around 38° to between 26° and 30°. It was planted with 50 000 tubestock in 2010–2011 and had specific management practices applied to minimise the impact on potentially present threatened species. In the 3 years since the works, there have been two major (>100-year intensity rainfall) events in the region, but there has been no evidence of erosion or slumping following

these events. Vegetation monitoring since that time has proven outstanding survival and growth rates of over 19 site-native species, with an average of over 35% cover in the monitored plots within 1 year (See Fig. 7 and www.emrprojectsummaries.org/2013/08/22/).
